# EDMONTON

DIAGNOSTIC IMAGING INC.  
ORAL & MAXILLOFACIAL

The examination consists of a cone beam computed tomographic scan extending from the frontal bone to the roots of the mandibular dentition. The image volume was reviewed and reformatted cross-sectional images were generated through the maxilla using 2 mm slice thicknesses at 2 mm intervals. Bone height and widths at two locations were measured in each orthoradial reconstruction; width at half-height and width at one-quarter height.

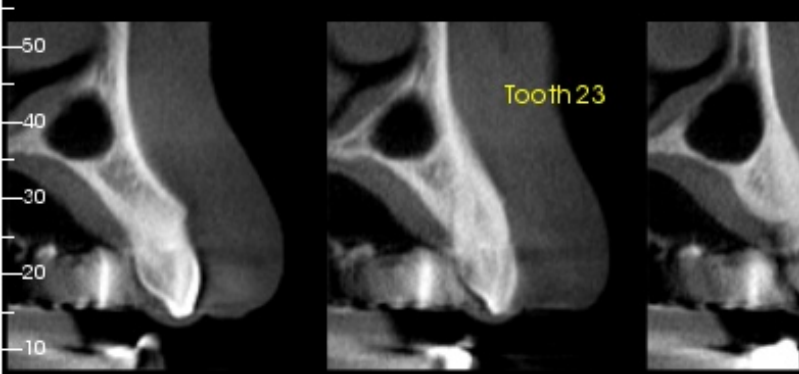
The following teeth are missing: 15, 14, 24, 26. Sample measurements were given in the 24 area. No osseous abnormalities were noted in the area of the proposed implant except for a punctate radiopacity in the alveolus in the 24 area which likely represents a small fragment of retained restorative material. The surrounding bone is normal. There is rarefying osteitis at the apices of 27. The periodontal ligament space at the apex of 25 is widened. This may be a normal variant or represent residual inflammation. There is associated mucosal thickening at the floor of the left maxillary sinus.

Tooth	Image	Height (mm)	Width ½ ht. (mm)	Width ¼ ht. (mm)
Maxilla				
2.3	89.49			
	93.49	11.24	8.46	8.12
2.4	95.49	12.04	7.25	7.36
	97.49	11.03	8.54	8.50
	99.49	11.64	8.43	8.64
